RELIANCE®

Bulletin No. REL-JD1.40-1 Group No. 1.40

Flywheel Modification.

Modification of flywheel may be required on some early 4010 and 4020 tractors at overhaul.

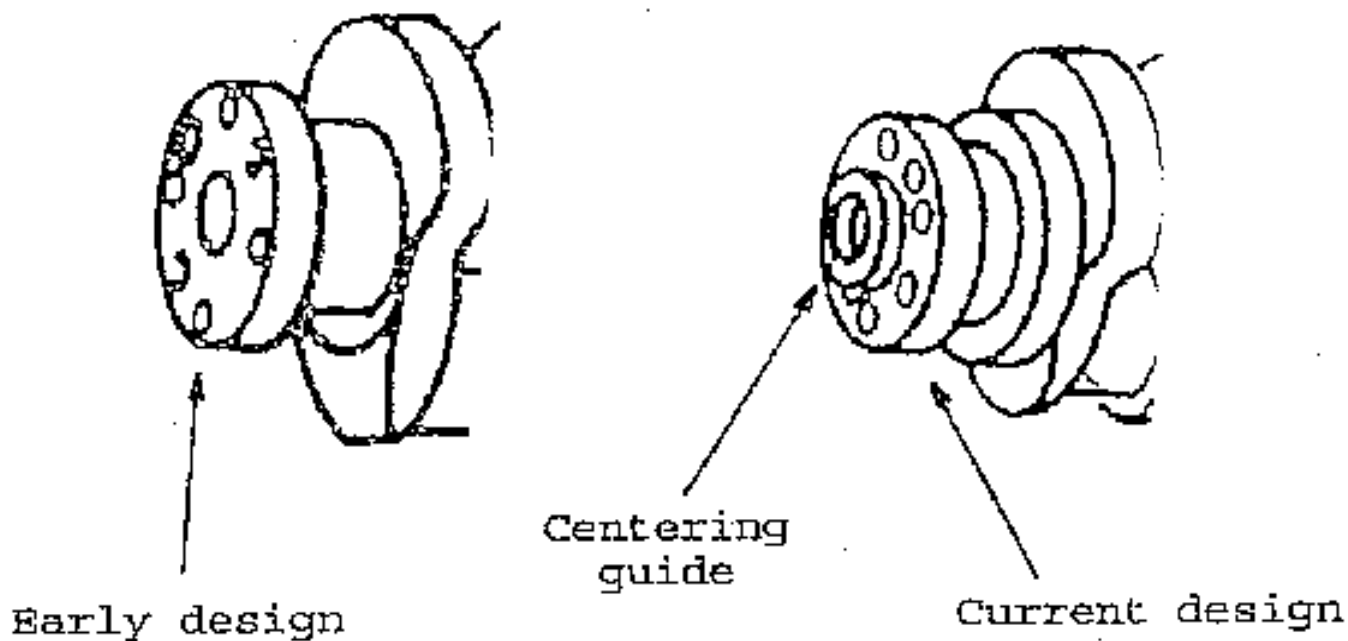
Some early design 400 Series engine crankshafts are no longer available as service parts. The hub of the substitution for this crankshaft has been changed and now incorporates a centering guide or step on the face of the hub. As a result, the flywheel previously used with the flat-faced hub will need to be modified by machining a 2.835 inch (72.01mm) hole in the center.
